Structural Review of Masterplan Proposals

Duncannon Fort
July 2023

Summary of structural condition, repairs required & current loading capacity

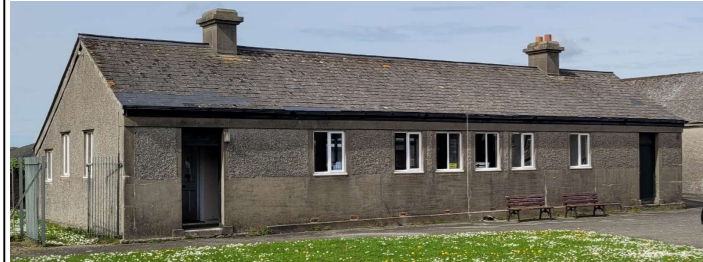
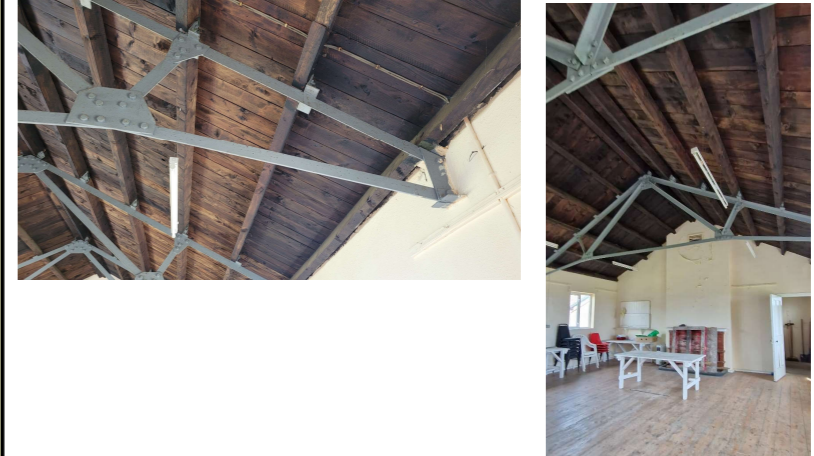
4 Soldier's Recreational Hall

Fair
Roof structure appears in fair condition, repainting of steel trusses required.
Timber floor sub-structure condition unknown, likely full overhaul required.
Opening-up works to the existing floor will help determine capacity.
Localised cracks in render to be repaired.

Unknown loading capacity, assume repairs/replacement required to floor to achieve public loading (5 kN/m2).

Public Building.
Likely that strengthening works will be required to floor, or a full new floor structure will be required.

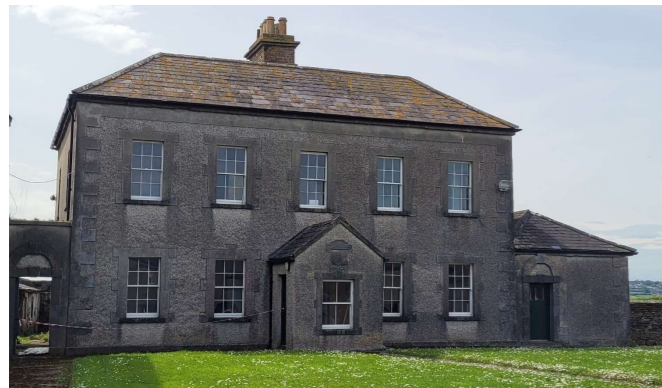
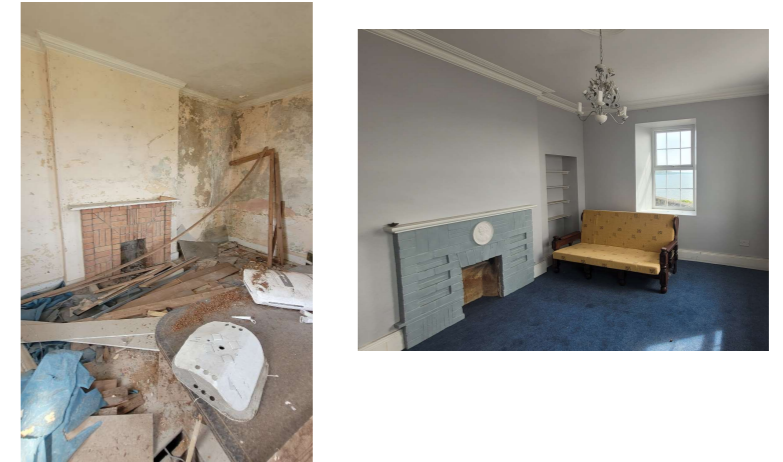
5 The Officer's Mess

Fair
External envelope in fair condition, despite inappropriate cement render.
Some rooms partially restored, in fair condition although dry-lining and finishes installed not appropriate and may cause issues in due course.
Leaking water tank in roof fixed but damage still remains.
Central brick chimney leaning, requires further survey and monitoring at minimum, may require significant repair works.
Poor ventilation causing mould issues.
Woodworm to timber including floorboards on ground floor.
Remedial works to ground and first floor, to include addressing ventilation and finishes issues.

**Ground floor: 5kN/m2 public loading
First floor: OK for domestic loading (1.5 kN/m2)**

Accommodation (i.e. Domestic Loading capacity)
Will need strengthening (i.e. doubling up of joists) under any new partitions on first floor.
First floor likely to require fireproofing, to detail by others.

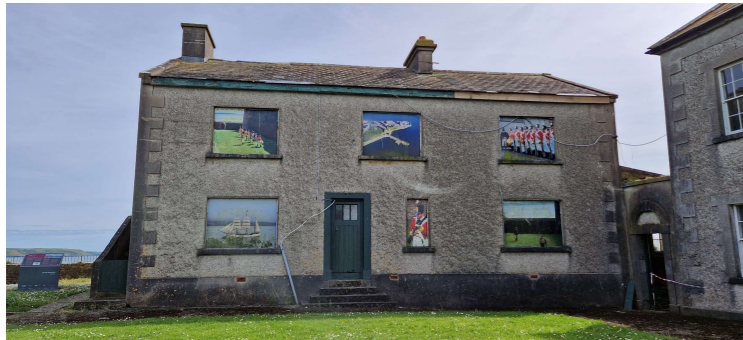
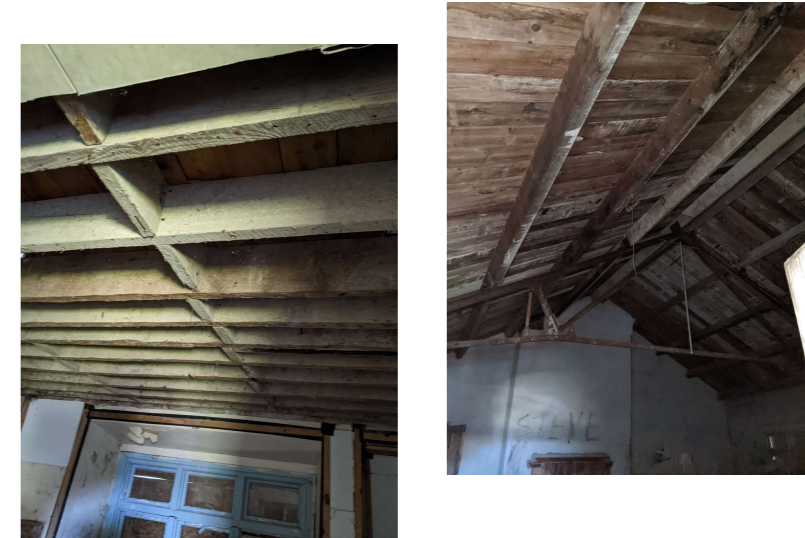
7 Burke's House
Three-bay two-storey concrete building c.1939
Two rendered chimneystacks
Exposed steel truss roof with timber purlins over
Timber floorboards on timber joists to ground and first floor

Poor
Water ingress and potential decay to roof timber elements
Floorboards missing locally, potential decay to structure below
Localised repairs/strengthening required to timber roof/floor structure
Timber trusses in need of repainting at minimum
Concrete door head compromised, potentially removed in past
Localised repairs required to concrete elements

Ground and 1st floor: domestic loading only if repairs carried out

None - likely to be demolished.
If retained, repairs required to ground and first floor to achieve anything above domestic loading.

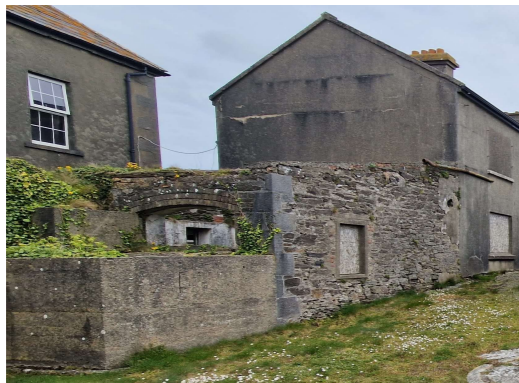
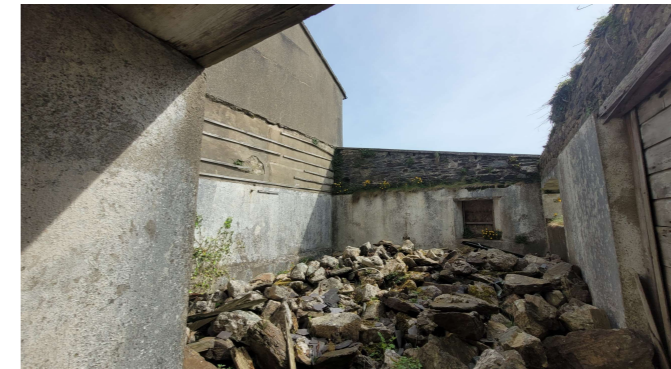
8 Burke's House - Store Houses
Roofless ruinous building abutting Burke's House, date unknown
Rubble masonry walls with fallen rubble internally
Lean-to roof (collapsed/missing)

Poor
Storehouses in poor condition due to lack of roof.
Upstanding masonry walls in reasonable condition, though vegetation growth on wall tops and on crevices, which should be removed.
Cementitious plaster and render on wall faces, which should be removed.
Any open/degraded mortar joints should be deeply repointed

Public loading (5 kN/m2) on solid floor.

No use identified currently.
Full new roof structure required if required as habitable space.

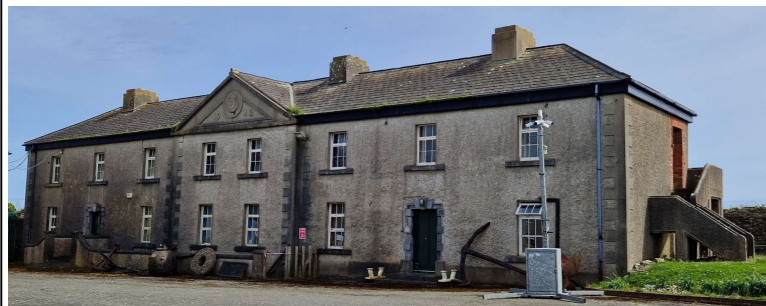
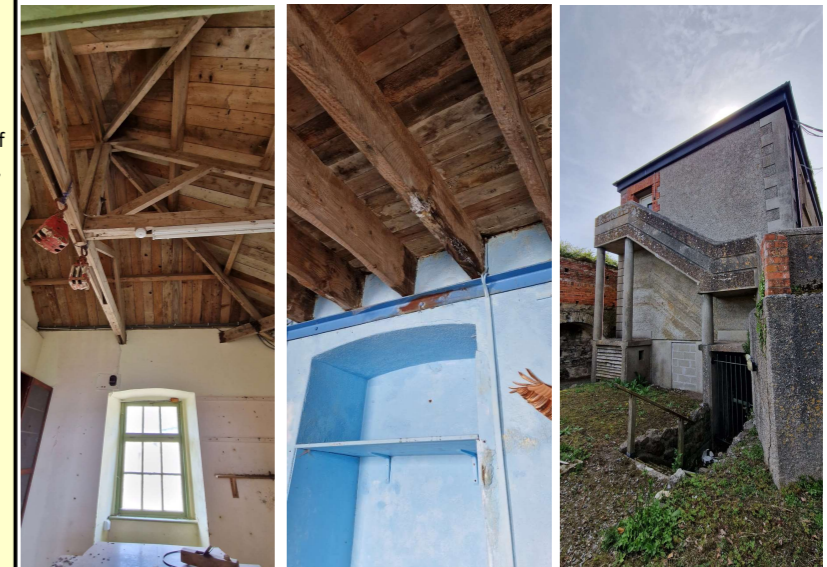
9 Governor's House
Eight-bay two-storey over basement c.1840, reconstructed 1943
Hipped slate roof on timber structure
Rendered roughcast masonry walls and chimneystacks
External cast concrete stairs

Fair
External envelope in fair condition, despite inappropriate cement render.
Timber roof structure appears in sound condition.
Water ingress on some walls due to leaks.
Localised repairs/strengthening required to first floor joists.
Concrete escape stairs to both gable ends in remarkably good condition but require local repair.
Suspended timber floors to first floor, some joists in need of splice repairs to decayed ends.
Ground floor may be vaulted masonry construction.
If suspended timber, repairs more than likely required.
Unknown basement construction or condition.
Opening-up works to ground floor/basement will help determine capacity.

Ground floor: assume public loading possible due to previous use, with repairs required (to be verified by opening-up works)

First floor: OK for domestic loading (1.5kN/m2) once repairs carried out.

Public Building.
Ground floor: if masonry vaults below, no strengthening required, subsequent to condition.
Strengthening works likely required otherwise.
First floor: strengthening works required, likely to include insertion of steel beams to shorten span of joists, doubling up joists under any new partitions, trimming out around stairways.
External gable end stairs can take full public loading but unlikely meet current escape criteria re: widths and balustrade heights.

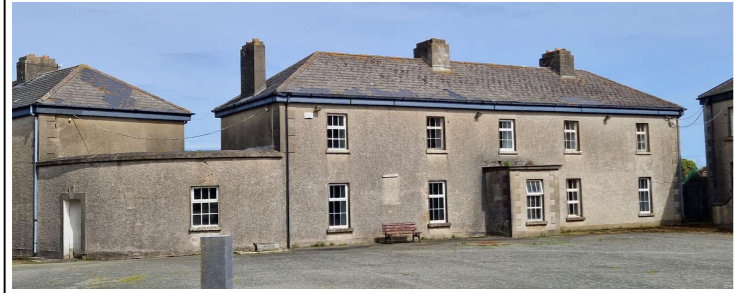
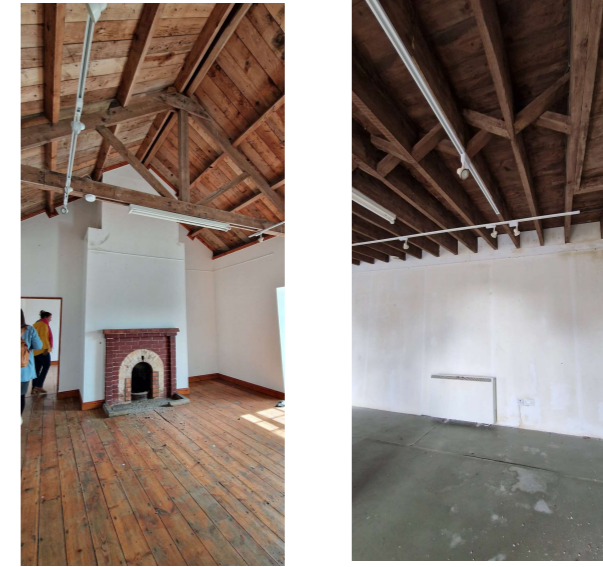
10 Officer Barrack
Five-bay two-storey c.1840 reconstructed 1939
Hipped slate roof on timber structure
Rendered roughcast masonry walls and chimneystacks
Curved single-storey wall linking buildings 10 and 11
First floor connected to Beach Rampart to rear via external bridges

Fair
External envelope in fair condition, despite inappropriate cement render.
Timber roof structure appears in sound condition.
Localised damp patches to walls and floor.
Localised repairs/strengthening required to first floor joists.
Curved linking wing showing significant signs of deterioration/movement.

Ground floor: Public loading (5 kN/m2) on solid floor.
First floor: OK for domestic loading (1.5kN/m2) once repairs carried out.

Public Building.
Ground floor: no strengthening required.
First floor: strengthening works required.
Strengthening works to floors likely to include insertion of steel beams to shorten span of joists, doubling up joists under any new partitions, trimming out around stairways.

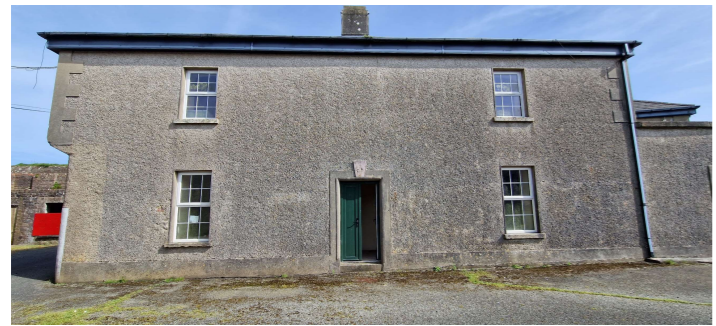
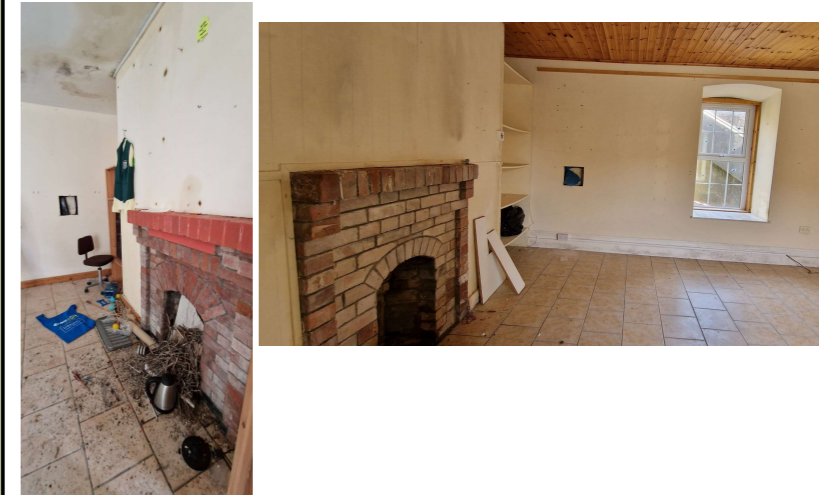
11 Soldier Barrack
Three-bay two-storey building c.1840 reconstructed 1939
Hipped slate roof on timber structure
Rendered roughcast masonry walls and chimneystacks
Curved single-storey wall linking buildings 10 and 11

Fair
External envelope in fair condition, despite inappropriate cement render.
Timber roof structure appears in sound condition.
Localised damp patches to walls and floor.
Localised repairs/strengthening required to first floor joists.

Ground floor: Public loading (5 kN/m2) on solid floor.
First floor: OK for domestic loading (1.5kN/m2) once repairs carried out.

Ground floor: Retail/workshop.
No strengthening required.
First floor: Accommodation.
Will need strengthening (i.e. doubling up of joists) under any new partitions on first floor.
First floor likely to require fireproofing, to detail by others.

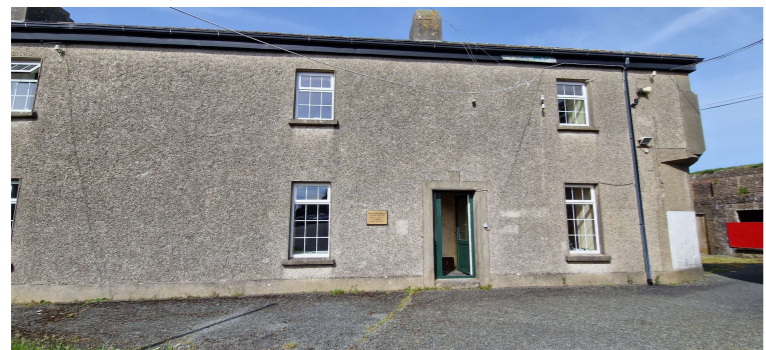
12 Soldier Barrack
Six-bay two-storey building c.1840 reconstructed 1939
Hipped slate roof on timber structure
Rendered roughcast masonry walls and chimneystacks
First floor connected to Marina Rampart to rear via external bridges

Fair
External envelope in fair condition, despite inappropriate cement render.
Timber roof structure appears in sound condition.
Localised damp patches to walls and floor.
Localised repairs/strengthening required to first floor joists.

Ground floor: Public loading (5 kN/m2) on solid floor.
First floor: OK for domestic loading (1.5kN/m2) once repairs carried out.

Ground floor: Retail/workshop.
No strengthening required.
First floor: Accommodation.
Will need strengthening (i.e. doubling up of joists) under any new partitions on first floor.
First floor likely to require fireproofing, to detail by others.

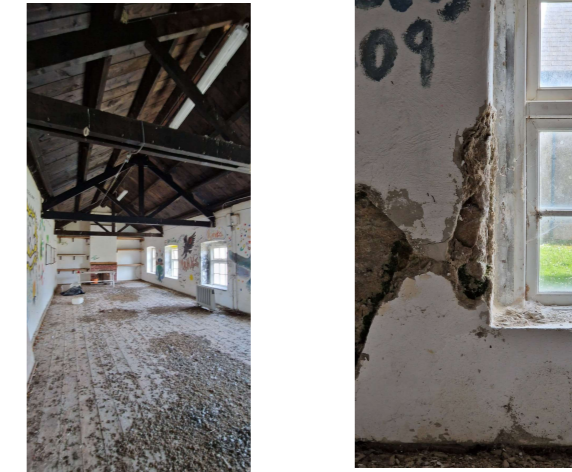
13 Barrack Store
Five-bay two-storey building c.1840 reconstructed 1939
Hipped slate roof on timber trussed roof structure
Rendered roughcast masonry walls and chimneystacks

Fair
External envelope in fair condition, despite inappropriate cement render.
Timber roof structure appears in sound condition.
Localised damp patches to walls and floor, plaster spalling locally.
Localised repairs/strengthening required to first floor joists.

Ground floor: Public loading (5 kN/m2) on solid floor.
First floor: OK for domestic loading (1.5kN/m2) once repairs carried out.

Ground floor: Retail/workshop.
No strengthening required.
First floor: Accommodation.
Will need strengthening (i.e. doubling up of joists) under any new partitions on first floor.
First floor likely to require fireproofing, to detail by others.

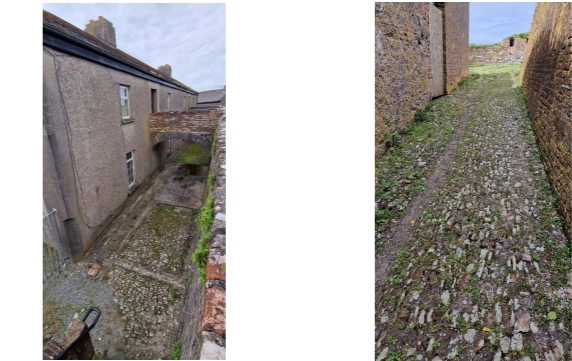
14 Laneways
Partially cobbled lane adjacent to building 12
Bridges connecting building 12 to rampart

Fair
Bridges connecting building 12 to rampart in fair condition, localised repairs to masonry spandrel walls and parapets
Cobbled surface priarily intact, some vegetation growth t be removed

Public loading (5 kN/m2) on solid floor.

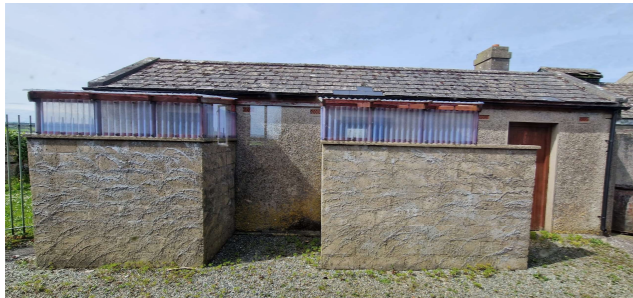
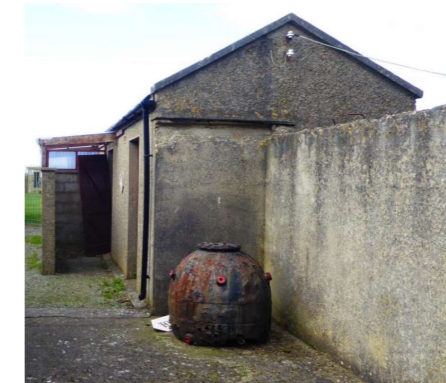
15 Toilet Block
Single-storey concrete building, assumed c.1939-1943 or more recent
Shallow pitch asbestos slate roof

Fair
Externally - fair condition, localised damp patches to base of walls
Internally - no access for survey

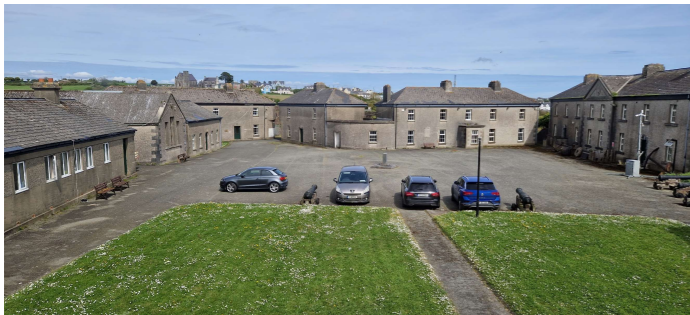
16 Parade
Open plan tarmacked area, surrounded by buildings predominantly facing inwards

Fair
Tarmacked surface in fair condition - refer to Civil/Transport engineer

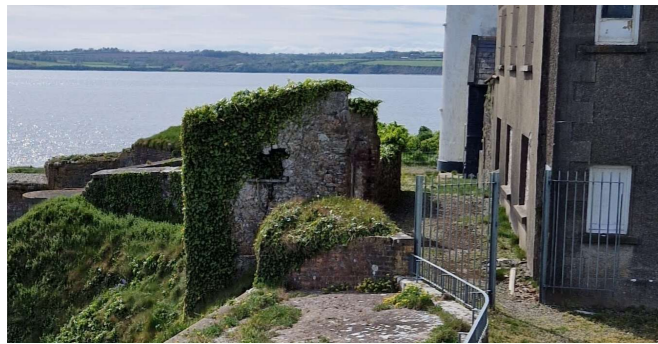
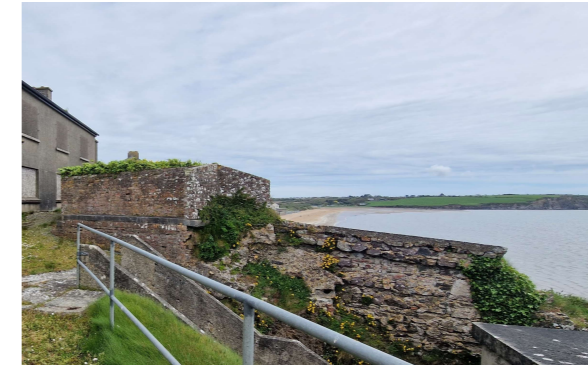
21 Tower
Square roofless ruinous masonry structure, date unknown

Poor
Significant vegetation growth to tops and sides
Collapsing window head to east
Breach to west infilled with blockwork

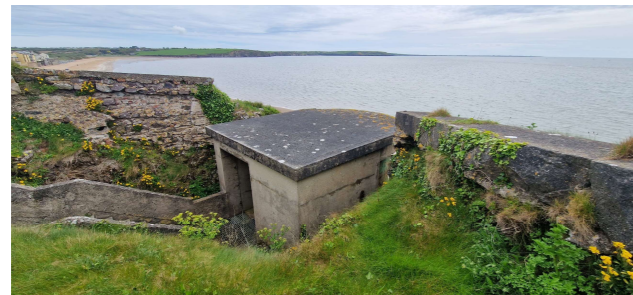
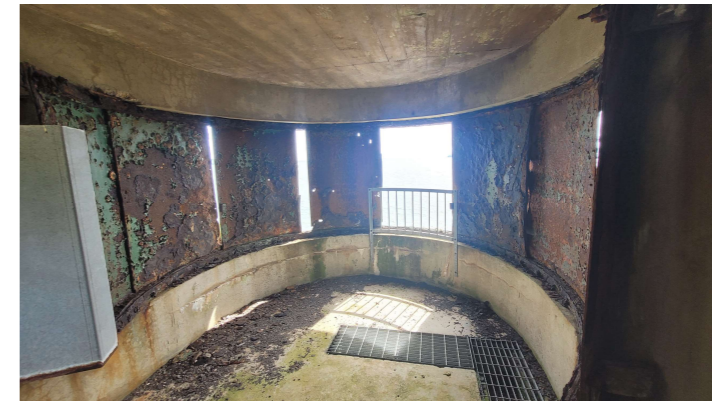
22 West Battery - Sunken Pill Box
Single-storey cast concrete structure with flat concrete roof, c.1939-1943
Solid concrete floor with trenches
Curved metal sliding shutters to sea-facing side
Accessed via concrete steps from ground level

Fair
Concrete structure in reasonable condition
Metal shutters badly corroding
Surrounding earlier masonry structure requires consolidation

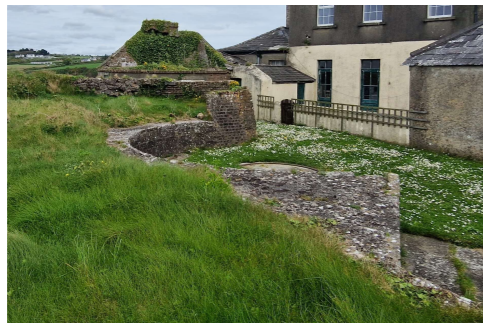
23 Gun Rings
Masonry retaining walls forming rounded bases for guns, date unknown
Iron gun base built into ground

Fair
Brickwork in fair condition
Vegetation growth to wall tops
Degraded brick to rear of northern ring, requires local consolidation

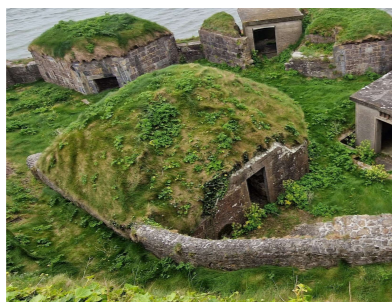
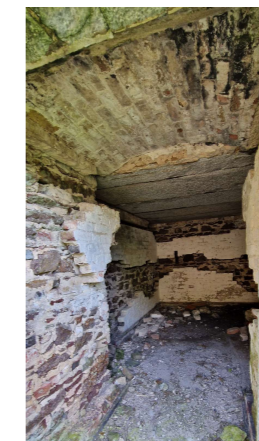
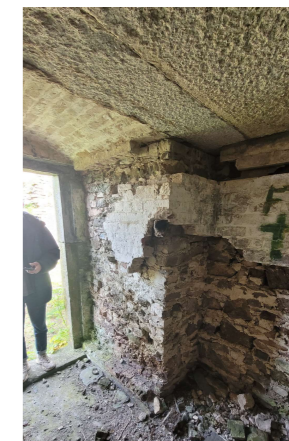
24 Munitions Store
Single-storey masonry building, date unknown
Dressed stone externally, brick liner walls internally
Vegetation growing on flat concrete roof, possibly intended as an earthen roof

Poor
Concrete roof structure to be investigated further internally, may require localised repairs.
Brick liner walls internally partially collapsed/dismantled, requires consolidation
Mortar washout externally, requires repointing

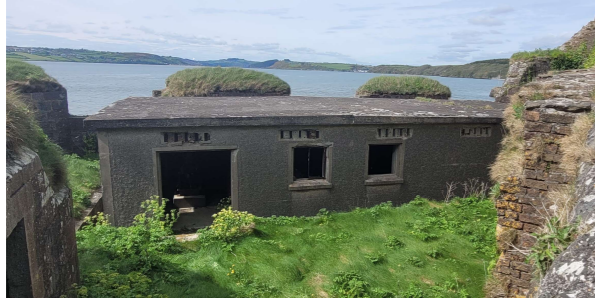
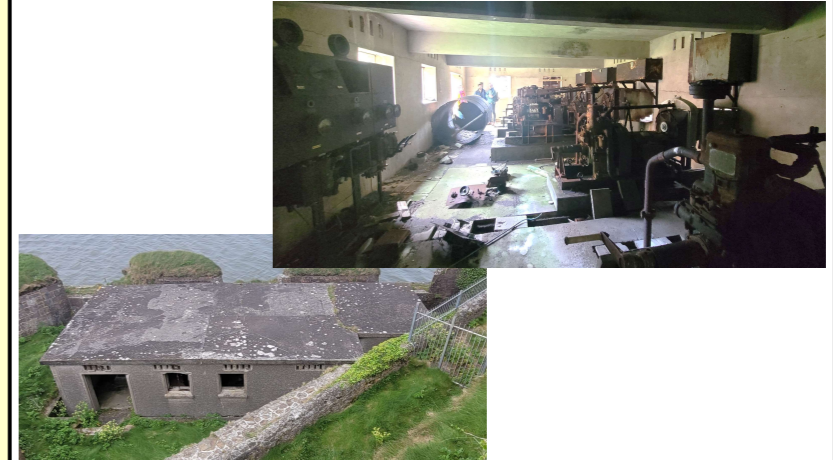
25 Generator Room
Single-storey cast concrete building c.1939-1943
Concrete downstand beams supporting flat concrete roof
Large rusting machines occupying much of floor area

Poor
Concrete roof deteriorating, cracks in roof covering, water ingress and vegetation growth
Possible presence of asbestos in machinery TBC

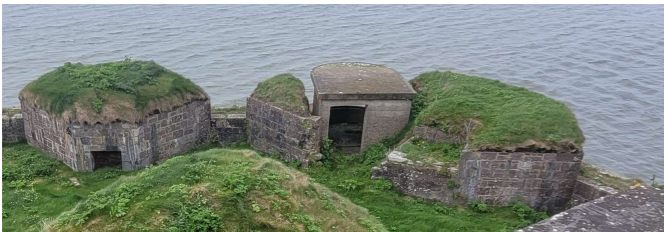
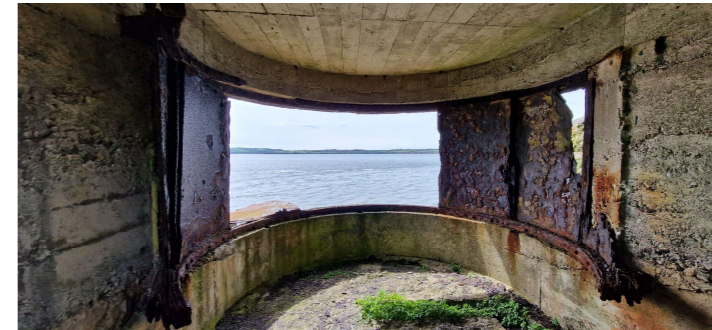
26 West Battery
Single-storey cast concrete structure with flat concrete roof, c.1939-1943
Solid concrete floor
Curved metal sliding shutters to sea-facing side
Set within older masonry battery structures

Fair
Concrete structure in reasonable condition
Metal shutters badly corroding
Surrounding masonry structure requires consolidation

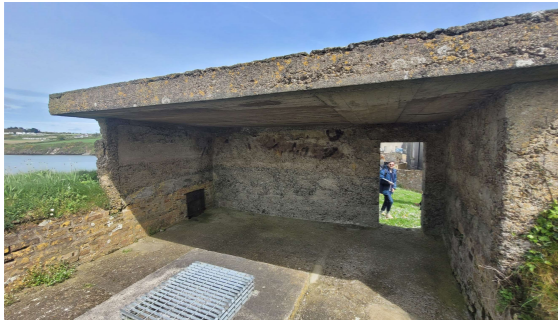
27 West Battery - Sea Pill box
Single-storey cast concrete structure with flat concrete roof, c.1939-1943
Solid concrete floor

Poor
Concrete structure spalling to underside (top of roof not seen)

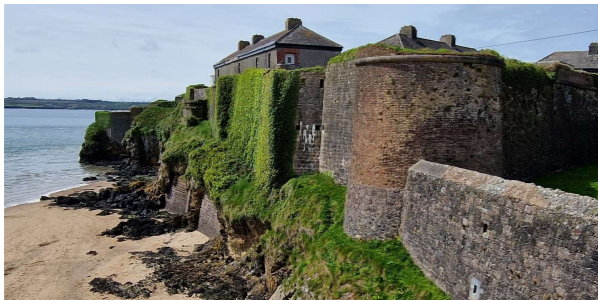
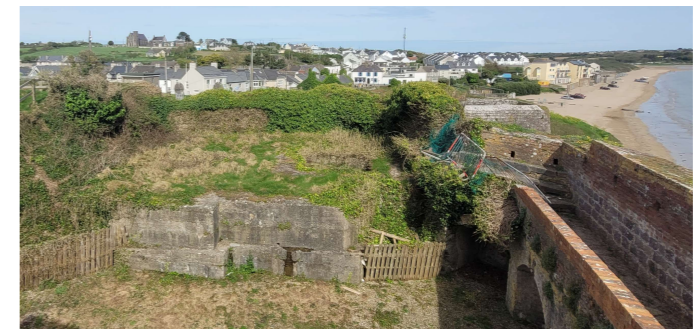
28 Beach Rampart
Masonry retaining wall with walkway and grassed area on top
Curved round tower at south corner, unknown date
Blind brick arches below walkway

Fair
Masonry in reasonable condition, localised repairs only

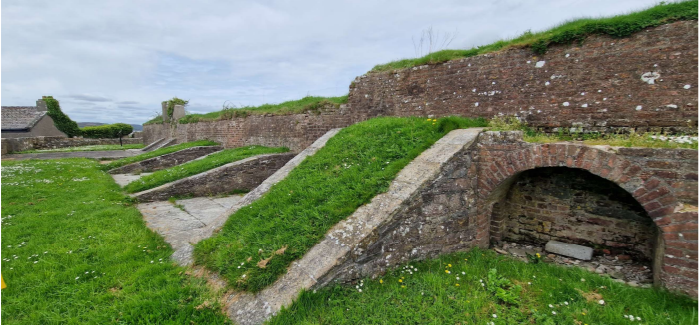
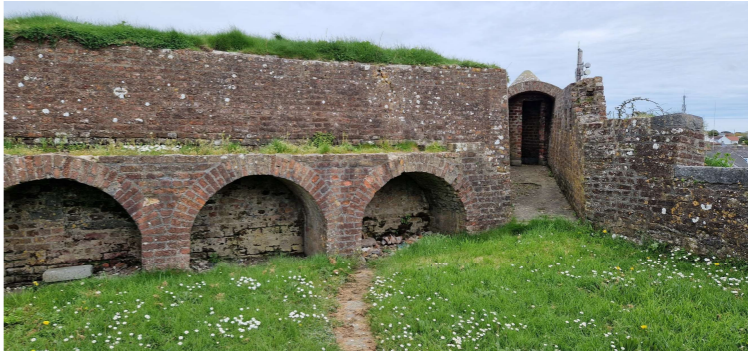
<p>Fair Masonry in reasonable condition, localised repairs only</p>

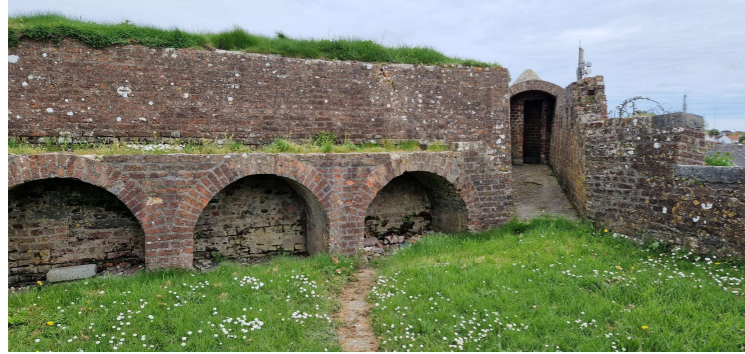
- 33 Circular Battery**
Single-cell pointed-roof lookout structure at apex of brick walls

Fair
Some mortar washout and vegetation growth
Localised repairs required to masonry only

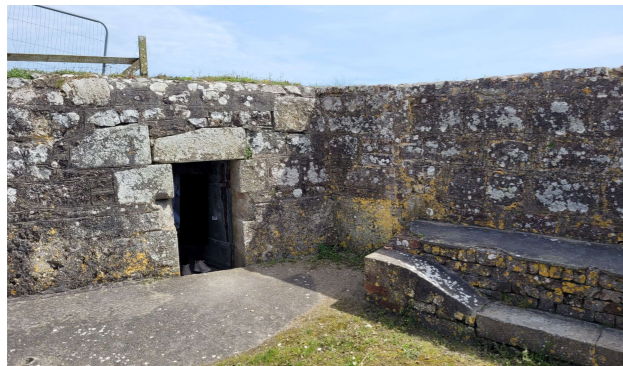
- 34 Casement Battery**
Rubble masonry walls overlooking beach cliffs

Fair
Some mortar washout and vegetation growth
Localised repairs required to masonry only

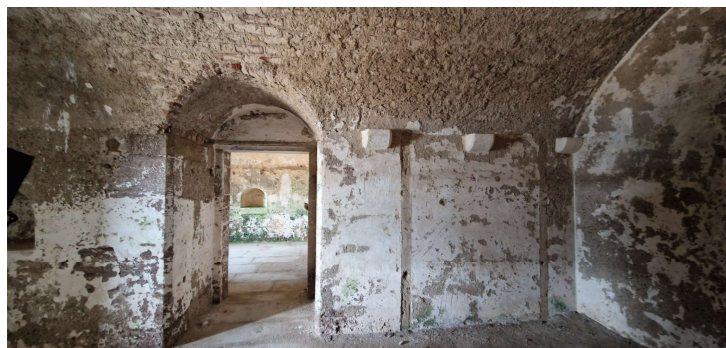
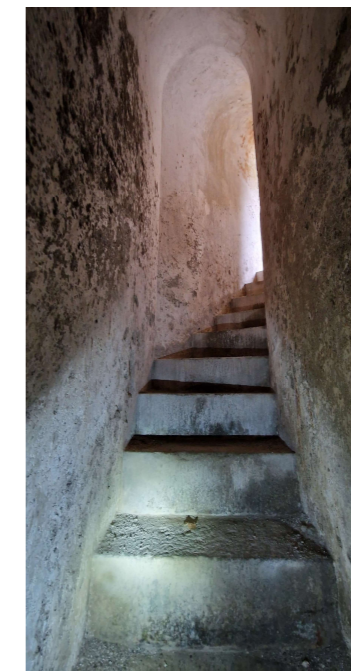
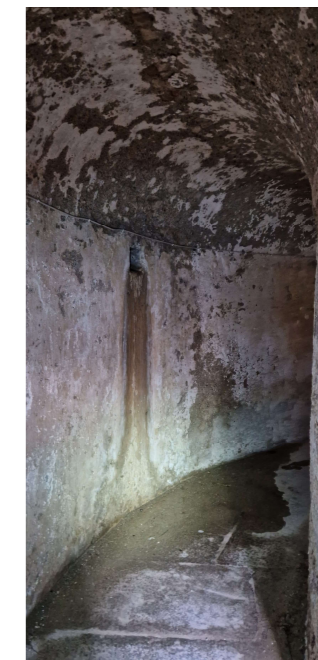
- 35 Croppy Boy Cell**
Underground multi-roomed area with vaulted masonry ceiling and walls
Lime plaster to walls and ceiling
Corbel stones to perimeter
Tiled stone floor

Fair
Lime plaster spalling but mostly intact
Solid stone floor in reasonable condition

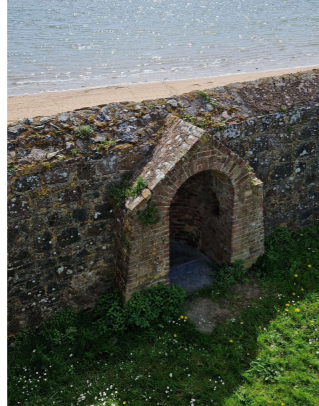
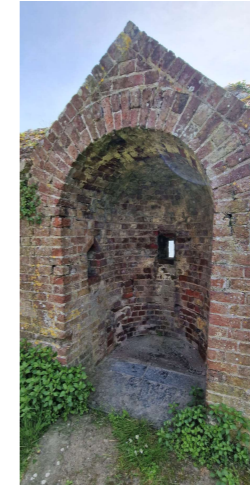
36 Embrasure of Southern Wall
Brick insertion into stone wall
Domed internally with slit windows

Fair
Some mortar washout and vegetation growth
Localised repairs required to masonry only

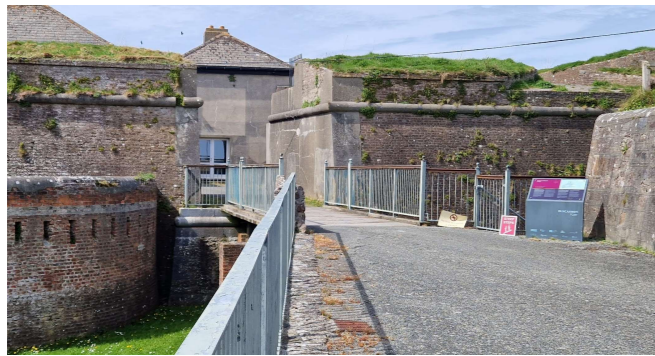
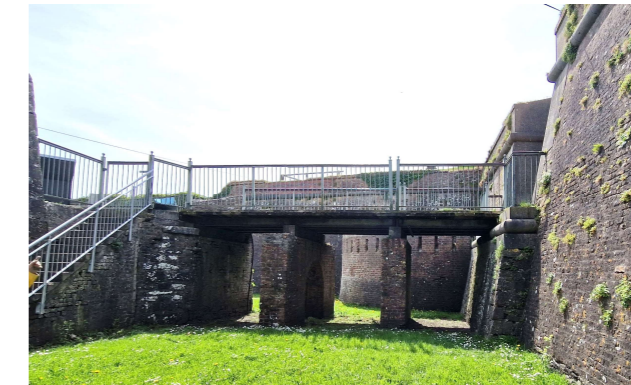
37 Bridge Entrance
Timber deck on concrete beams bearing on brick piers

Poor
Some mortar washout and vegetation growth on brick piers
Localised repairs required to masonry
Replacement deck and beams likely required (understood to be carried out under separate contract)

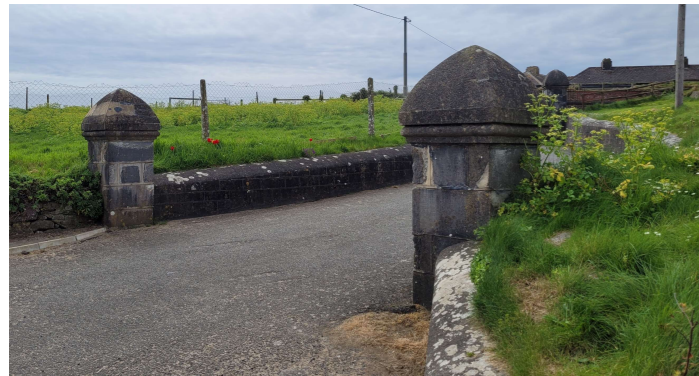
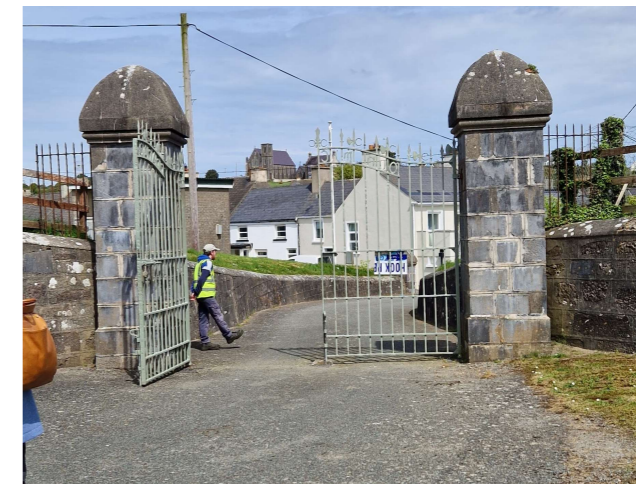
38 Main Entrance
Carved stone pillars at lower and upper entrance with flanking stone wall connecting both sets of pillars

Fair
Some mortar washout and vegetation growth on brick piers
Localised repairs required to masonry
