DUNCANNON FORT, CO. WEXFORD

HERITAGE REPORT

Alastair Coey Architects

August 2023

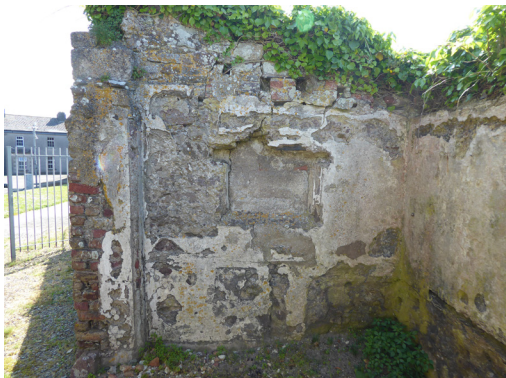
Fig.9: East wall

- Extensive vegetative growth to outer faces
- Structural crack to east wall caused by vegetative roots
- Extensive deterioration of lime plaster

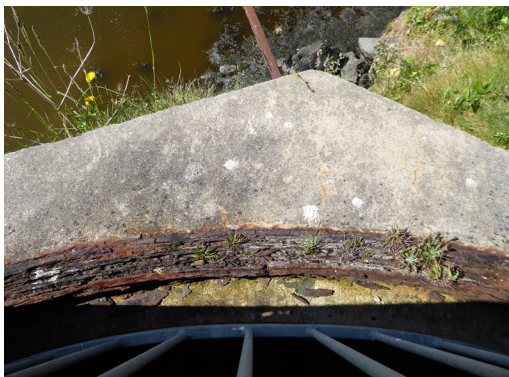
Fig. 12: Corroded iron tracks to screens

- Iron screens heavily corroded and de-laminated as a result of long-term exposure to sea air
- Ashlar limestone to gun emplacement falling away to left-hand-side with substantial copings approximately 400mm deep

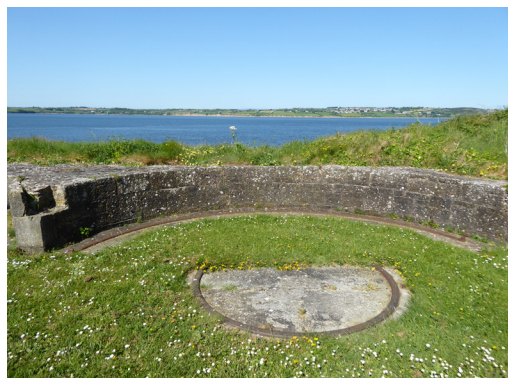
Fig. 15: North gun ring and central section

- Concrete surface finish applied to central splayed section, stone paving may survive beneath
- Strong cement mortar pointing to battered brick wall to north side, accelerating deterioration
- Structural crack where wall returns westward
- Upper courses and brick-on-edge coping missing to returned section of wall

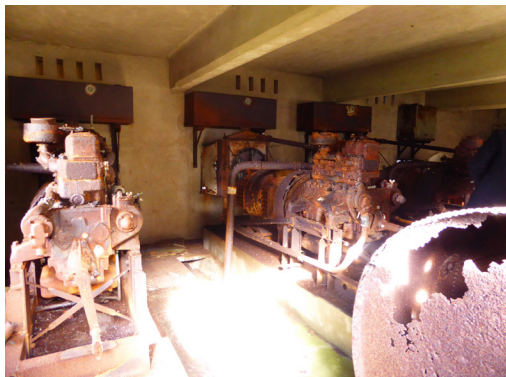
Fig. 21: Surviving generators

- Generators heavily-rusted, likely beyond point of refurbishment

It is also hoped that the extant generator equipment can be showcased as a surviving element of the sites World War two history. Further investigation will be required to establish the feasibility of removing the equipment for off-site refurbishment or retaining in-situ and encasing in display units.

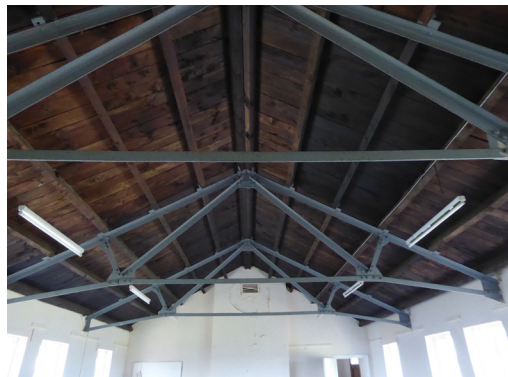
Fig. 48: Wrought-iron trusses

- Rubble stone constructed with bricks dressed openings, evident where later render missing
- Detached area of render to north elevation exposing stonework and brickwork possibly delineating former chimney flue
- Roof structure appears to be wrought-iron trusses carrying timber purlins and vertical sarking boards

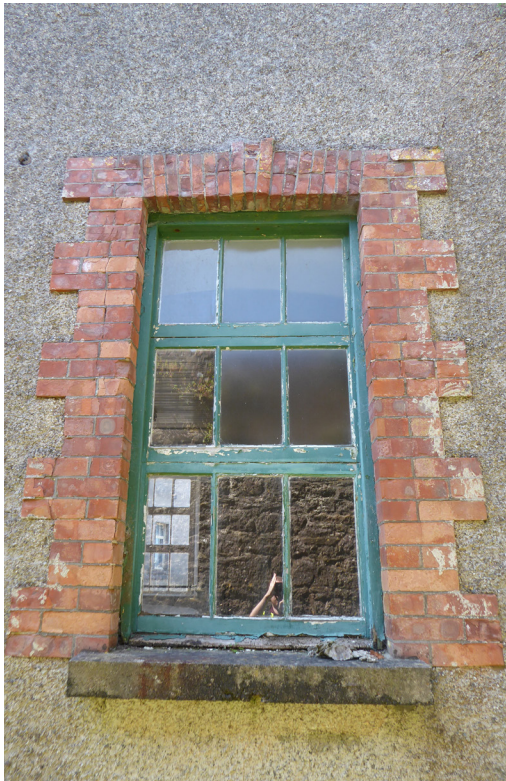
Fig. 81: Window to east elevation

- Major structural crack over window to quadrant wall
- Extensive spalling to soffit of bridge
- Sills rounded and worn to east elevation
- Extensive cracking to brick arches over windows to east elevation
- Wrought-iron window grille heavily corroded
- Door and steps to north side of east elevation in very poor condition

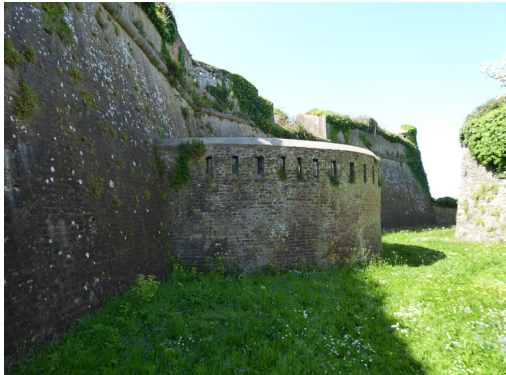
- Cement-based render and capping falling away
- Fracturing of stone caused by expansion of wrought-iron latch plate

Fig. 113: Exterior wall, south side

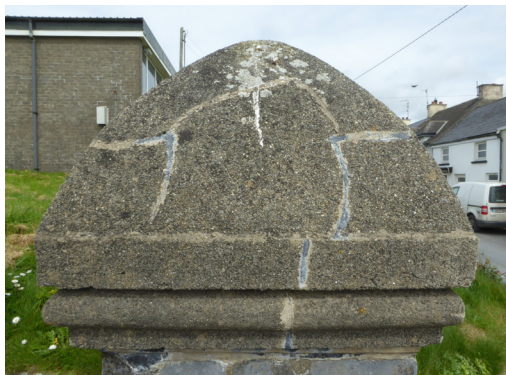
Fig. 134: Extensive cracking to pier cap
