Courtown and Riverchapel Local Area Plan 2015-2021

Appendix 4

Coastal Path

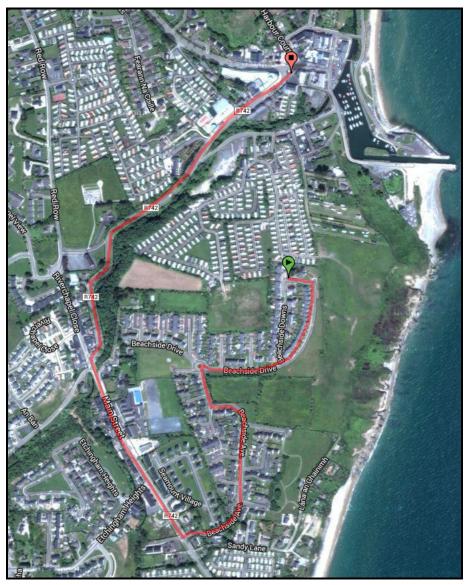
The residents of Beachside Estate have a considerable walk to Courtown village centre. It is necessary to follow a route marked from start to finish shown on Figure 1 below. This distance is approximately 2.4km and some of the walk (between Riverchapel and Courtown) lacks footpaths.

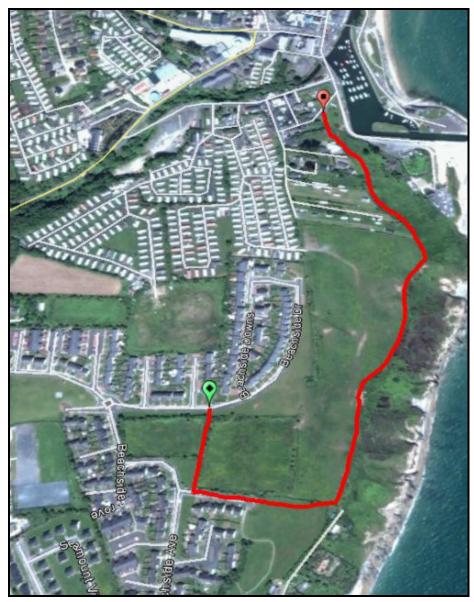
Figure 2 below shows the route if access to the coastal pathway was restored and upgraded. The distance to the town centre from Beachside Dale would be reduced from 2.4km to 1km.

An improved and re-instated coastal path could provide a link from Beachside Estate to the village centre. The walking distance would be reduced and would encourage individuals and families to walk to the village centre instead of making a car journey. It would make an enormous difference to the lives of children and young people and to those who do not own cars.

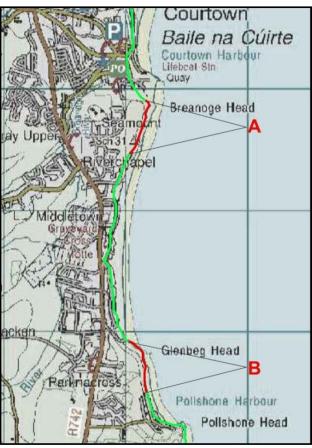
Figure 3 to the right shows the route of the coastal pathway. The sections which are

passable are shown in green while sections that are **impassable** are shown in red.

The existing pathway from Courtown to the end of the grassy track on Breanoge Head is passable (0.5km). It requires upgrading and improvement, subject to further feasibility and environmental studies prior to the deciding on the design.

From here, there is heavy undergrowth and steep terrain with severe erosion (Area A). This section of the coastal pathway is no longer accessible (0.6km).

Beyond this, the pathway is passable to a point just north of Glenbeg Head where the route goes onto the beach (1.6km). From the previous point north of Glenbeg Head to Parknacross, the pathway leaves the beach and is impassable at high tide and there is no access off the beach. This section is shown as **Area B** (0.6km).

As the pathway continues south after this towards Pollshone Harbour it is passable (0.5km).

Area A is impassable due to the collapse of the existing pathway. There are sufficient private lands to the west of the collapse which could accommodate a re-routing of the pathway to link it with the suitable sections running to the north and south of this area.

Unsuitable sections include those which are passable with difficulty (e.g. climbing over rocks) or beach sections either impacted by the tide or stony beaches which are difficult to walk on, such as **Area B**.
