Structural Review of Masterplan Proposals

Duncannon Fort
July 2023

Summary of structural condition, repairs required & current loading capacity

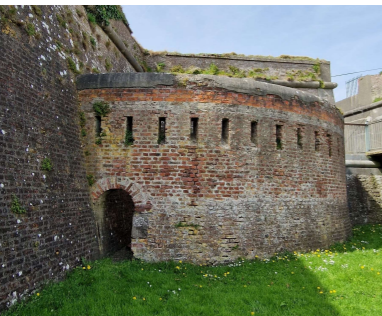
<p>Fair condition Spalled bricks require repair Cement cap requires replacement with more appropriate lime cap</p>

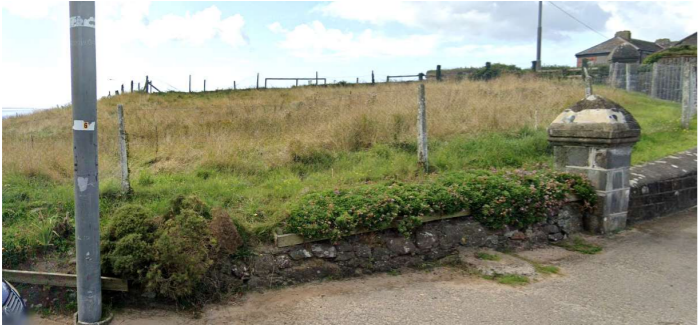
<p>30 Beach Glaci Grassed area to south of main entrance, enclosed by flanking entrance masonry walls</p>

<p>Fair Localised repairs to walls only</p>		
<p>31 Marina Glaci Grassed area to north of main entrance, enclosed by fence and retaining masonry walls Historic graveyard to north end of field</p>  	<p>Fair Localised repairs to walls only</p>		
<p>32 Telecoms Box Single-storey single-cell masonry structure, date unknown</p>  	<p>Fair (no access internally) Understood to be outside of project remit</p>
