DUNCANNON FORT, CO. WEXFORD

HERITAGE REPORT

Alastair Coey Architects

August 2023

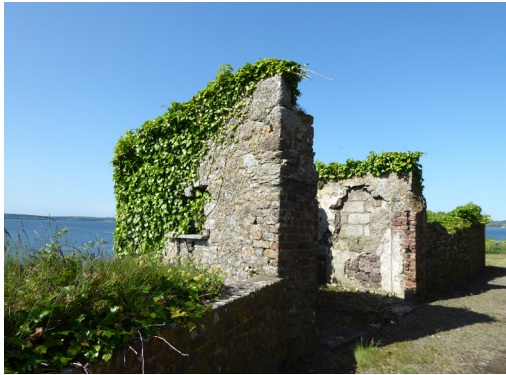
Fig. 7: No.21 Tower

- Extensive vegetative growth to outer faces
- Structural crack to east wall caused by vegetative roots
- Extensive deterioration of lime plaster

No specific use is proposed for this heritage asset as part of the current masterplan, other than its continued interest as a surviving feature and part of the wider interpretation of the site. The tower has potential for use as a viewing point through the introduction of an independent raised platform with steps, which may or may not be tied back to the existing structure.

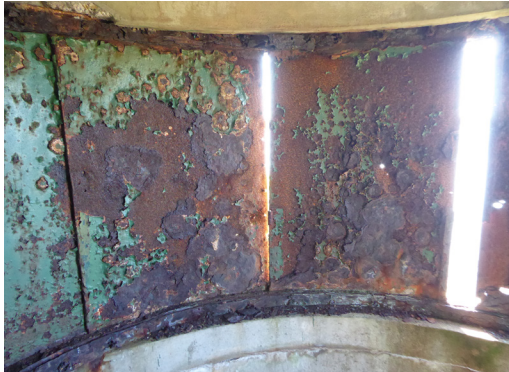
Fig. 11: Surviving iron screens

- Iron screens heavily corroded and de-laminated as a result of long-term exposure to sea air
- Ashlar limestone to gun emplacement falling away to left-hand-side with substantial copings approximately 400mm deep

No specific use is proposed for this heritage asset as part of the current masterplan, other than its continued interest as a surviving feature and part of the wider interpretation of the site. The pill box, and other similar surviving military structures on the site, have potential for use as interpretation pods and for framing specific vantages of the estuary and nearby attractions and historical monuments. The refurbishment or replacement of existing sliding iron shutters also presents an opportunity to incorporate interpretation boards.

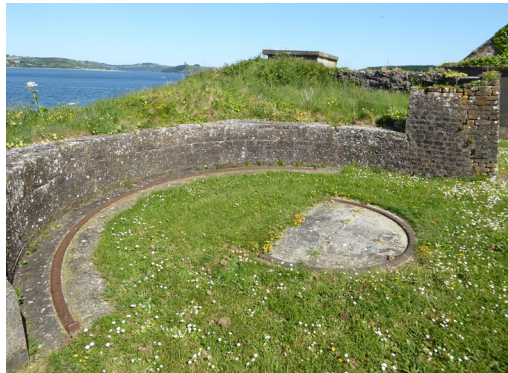
Fig. 14: North gun ring and wall to north

- Concrete surface finish applied to central splayed section, stone paving may survive beneath
- Strong cement mortar pointing to battered brick wall to north side, accelerating deterioration
- Structural crack where wall returns westward
- Upper courses and brick-on-edge coping missing to returned section of wall

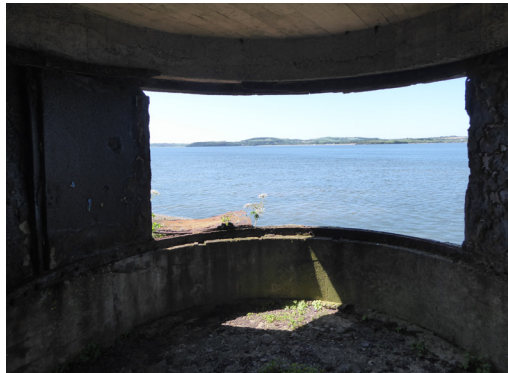
Fig. 23: Surviving iron screens

- Crude breaking through of former battery to accommodate construction of pillbox
- Iron screens heavily corroded and de-laminated as a result of long-term exposure to sea air

No specific use is proposed for this heritage asset as part of the current masterplan, other than its continued interest as a surviving feature and part of the wider interpretation of the site. The pill box, and other similar surviving military structures on the site, have potential for use as interpretation pods and for framing specific vantages of the estuary and nearby attractions and historical monuments. The refurbishment or replacement of existing sliding iron shutters also presents an opportunity to incorporate interpretation boards.

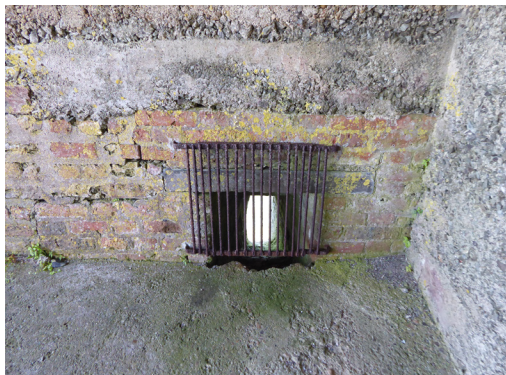
Fig. 27: Drainage chute to north wall

- Large drainage chute in north wall discharging to sea has dressed stone lintel suggesting earlier date and wrought-iron grillage heavily rusted.
- Evidence of brick wall at low level on north, south and west walls suggest a possible earlier structure.

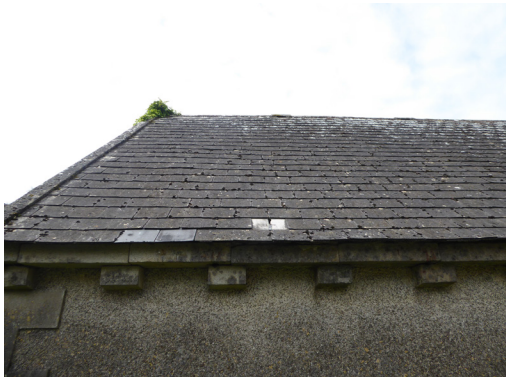
Fig. 31: Eaves course and corbels

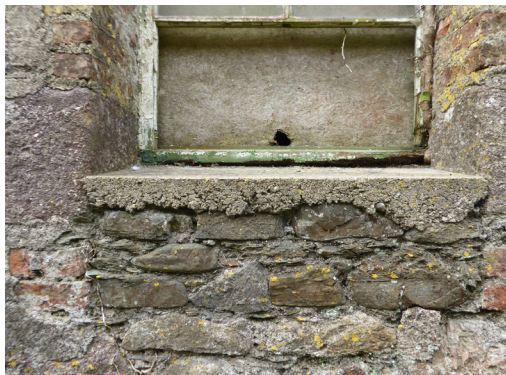
Fig. 39: Reconfigured window sills

- Corrugated asbestos roof with major hole repaired with corrugated tin to north
- Extensive spalling to concrete window sills
- Condition of all timber windows ranging from poor to very condition
- Isolated areas of vegetative growth
- Isolated areas of cracking to cement-based wet dash
- Timber fascia in very poor condition
- Timber sheeted door to west elevation in very poor condition
- No surviving rainwater goods
- Zig-zag crack to north end of east elevation
- Redundant insulated power cable bracketing in gable

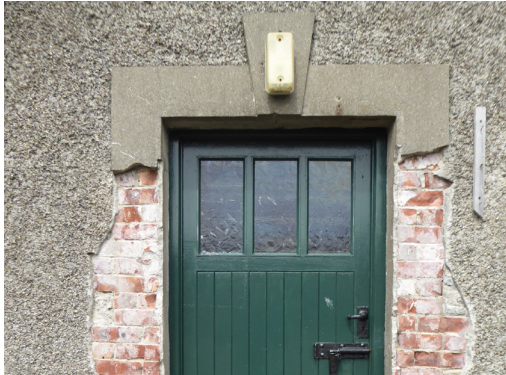
Fig. 43: Entrance door and surround

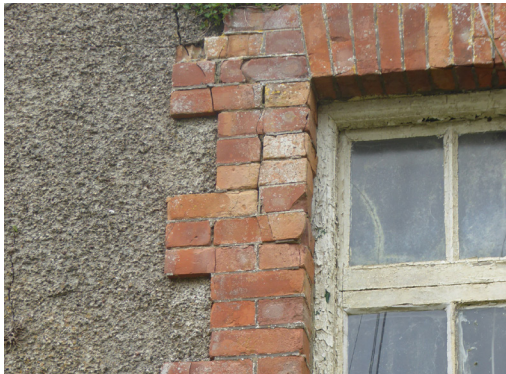
Fig. 44: Brick surround to east window

- Extensive areas of detachment, falling away and cracking of cement-based render
- Fibre-cement slate roof with several isolated repairs
- Some cracking to brick reveals to window to east elevation, also some surface deterioration of brickwork

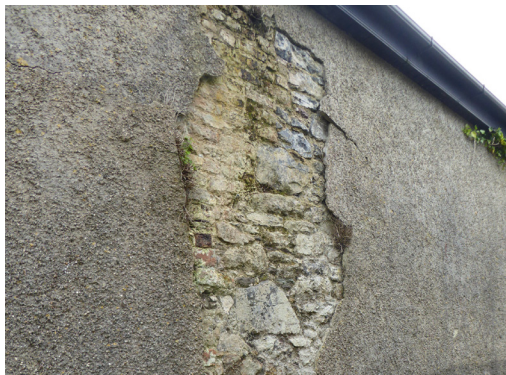
Fig. 45: Detached render to north elevation

- Rubble stone constructed with bricks dressed openings, evident where later render missing
- Detached area of render to north elevation exposing stonework and brickwork possibly delineating former chimney flue
- Roof structure appears to be wrought-iron trusses carrying timber purlins and vertical sarking boards

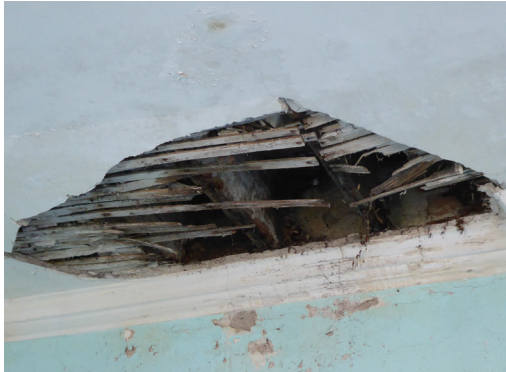
Fig. 58: Collapsed plaster to lath and plaster ceiling

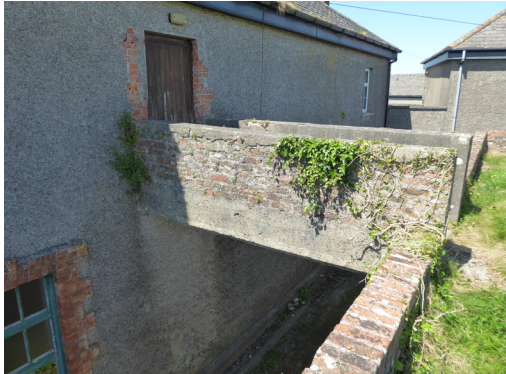
Fig. 80: First floor bridge to east elevation

- Major structural crack over window to quadrant wall
- Extensive spalling to soffit of bridge
- Sills rounded and worn to east elevation
- Extensive cracking to brick arches over windows to east elevation
- Wrought-iron window grille heavily corroded
- Door and steps to north side of east elevation in very poor condition

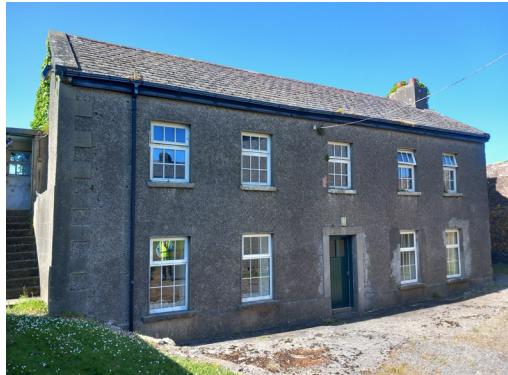
Fig. 93: South elevation

- Fibre-cement slate roof
- Replacement of all windows in uPVC
- Flanking walls to bridges in poor condition, cement-based render falling away and evidence of cracking

It is recommended that roofs be re-slatted in natural slate, in conjunction with other works (rainwater goods, insulation, etc). Slate roofing is a traditional roofing material with exceptional durability and proven longevity, which is cost effective over the lifetime of a building. Works to roofs should also include complete renewal of all lead valleys, gutters and flashings to the correct code, as well as salvaging and reinstatement of surviving terracotta and blue/black clay ridge and hip tiles and chimney pots.

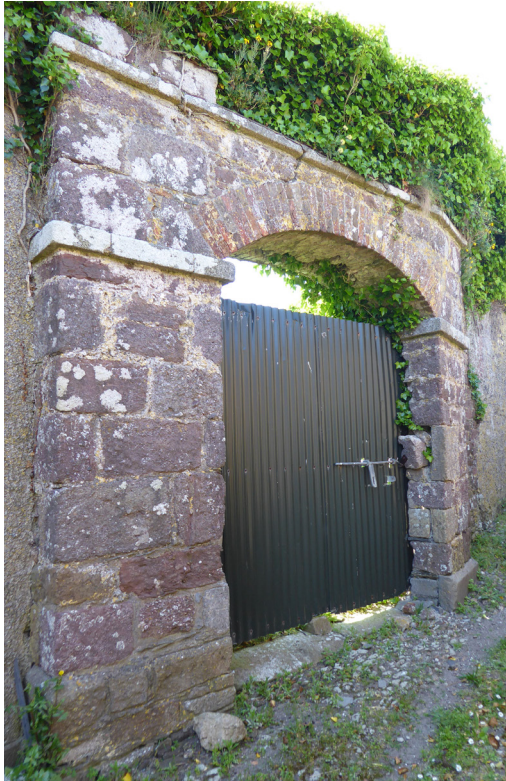
Fig. 96: Brick archway to rear yard

Segmental arched opening cranked on plan. Coursed rubble stone side piers on rubble stone base to south side and dressed ashlar plinth to north side, extensively worn stone threshold, granite platbands at springing level of brick arch, one-and-a-half-brick arch, corrugated-iron gate leading to yard. Opening surmounted by projecting ashlar granite string course with conglomerate stone block course above, largely concealed by vegetation. Wall to north of gateway comprising red sandstone walling projecting approximately two metres beyond gateway then changes to uncoursed rubble shale, wall contains brick dressed opening infilled with brick and remnants of lime-based wet dash clinging to wall surface, opening to north infilled with strawboard panel, return wall collapsed further north.

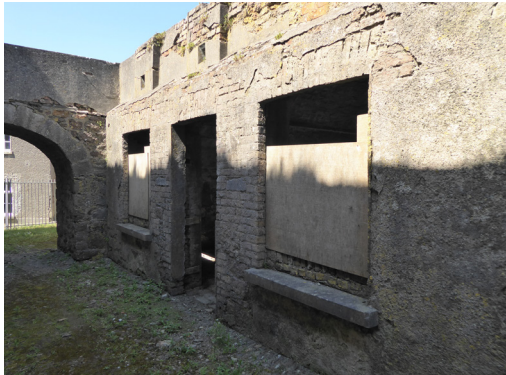
Fig. 99: Bake House

Brick arched openings to either side of square-headed door opening, both partially built-up, ashlar limestone sills, brick dressings to reveals, in fact wall mainly brick with cement roughcast. Internally, 3no. brick segmental vaults carried on wrought-iron beams, limewash on rubble stone wall, evidence of potential openings built-up, large wrought-iron horizontal member to right-hand-side of central wall, purpose not clear. Brick piers to either side of door opening having limestone padstones carrying wrought-iron beams. Timber lintels over window openings have disappeared. Remains of stone slab flooring.

- Some voiding and vegetation growth
- Extensive cracking of upper surface to steps leading to Beach Rampart
- Extensive damp staining to Bake House internal walls
- Extensive cement-rich pointing exacerbating decay of brickwork
- Roughcast render extensively detaching to exterior of Bake House

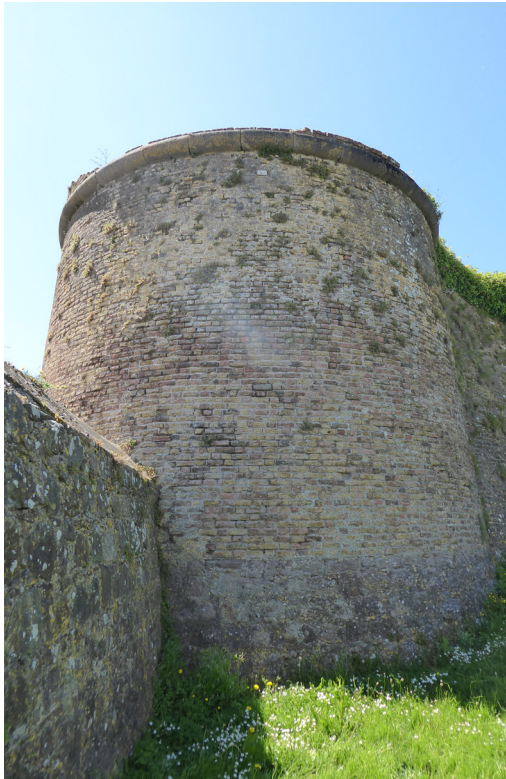
Fig. 105: Bastion

- Brickwork to top of bastion in poor condition
- Widespread vegetative growth
- Extensive repointing in cement-rich mortar
- Some open joints evident to brickwork
- Significant raising of stonework to tunnel entrance at north lunette as a result of wrought-iron expansion

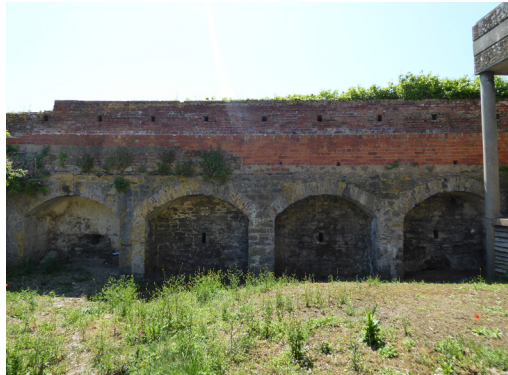
Fig. 121: Recessed arches

- Substantial collapse of brick arch to eastern-most arched recess
- Cracking to soffit of eastern-most arch
- Brick in exceptionally poor condition to arches to rear of building No.9

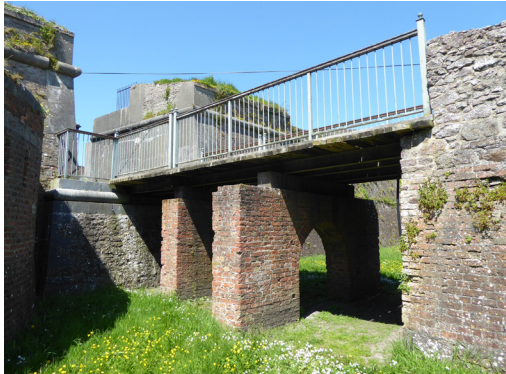
Fig. 124: Existing bridge

Battered wall, battered also at both ends, capped with vertical limestone string course capped by bullnose tooled ashlar limestone string course returning to both sides, sections missing below bridge deck, hole in base of wall beneath centre of bridge, purpose not clear.

- Some cracking bridge deck

The bridge is to continue to function as the primary access and egress route to and from the site. It is due to be replaced in the upcoming interim refurbishment works to be undertaken by the Council.

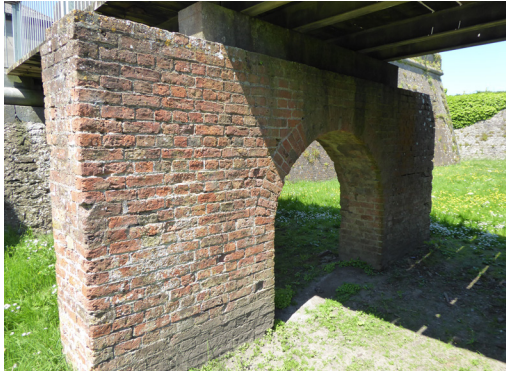
Fig. 125: Brick pier under bridge

- Intact walls below later replacement bridge

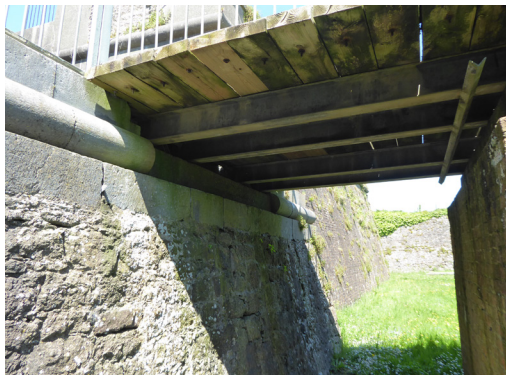
Fig. 126: Battered wall and bridge connection

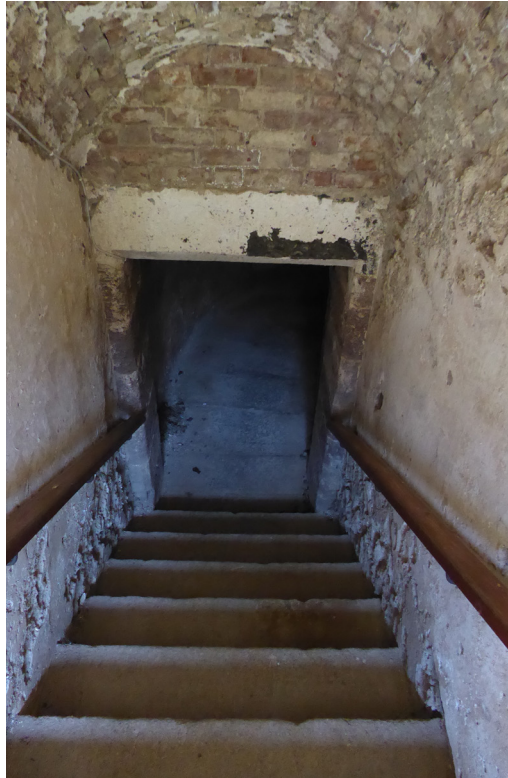
Fig. 127: Entrance steps

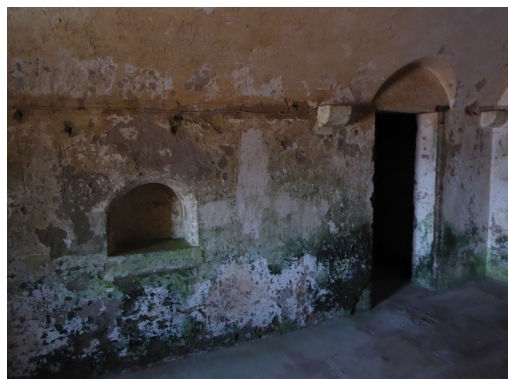
Fig. 128: Room one

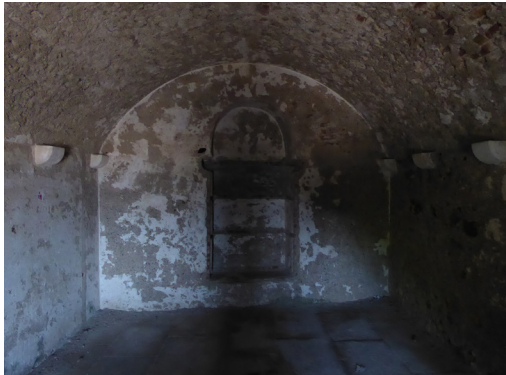
Fig. 129: Room five, recess

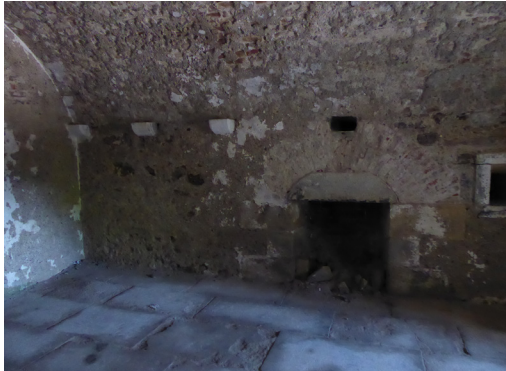
Fig. 130: Room five, fireplace

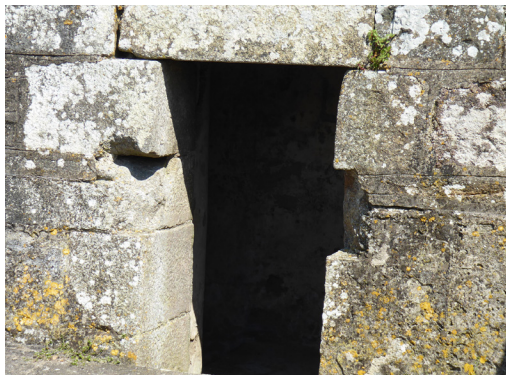
Fig. 131: Exit opening from cells

- Heavily corroded sheet steel door
- Limewash on lime plaster extensively fallen away to entrance exposing brick construction
- Extensive deterioration of surviving lime surfaces

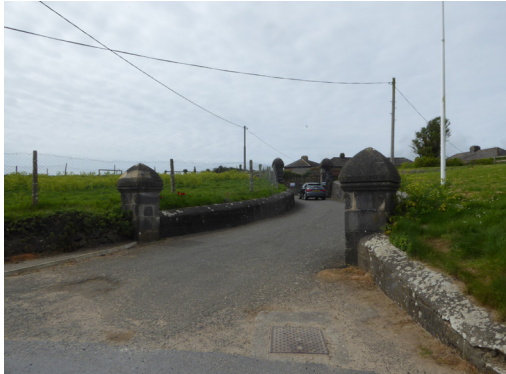
Fig. 132: Lower piers from Duncannon

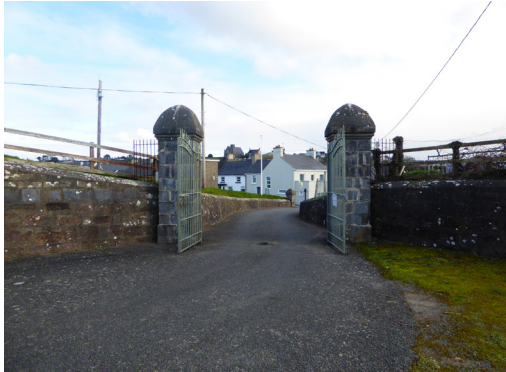
Fig. 133: Piers and gates leading to site

- Extensive cracking with previous evidence of repairs
- Lichen growth
- Cement-rich strap pointing

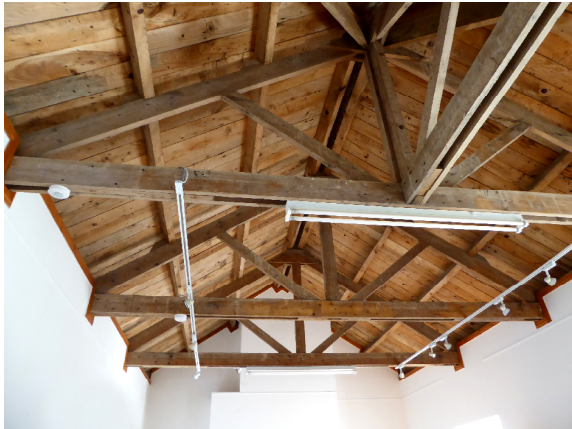
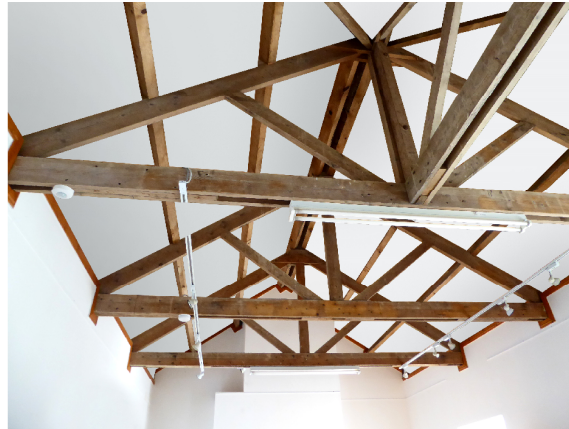
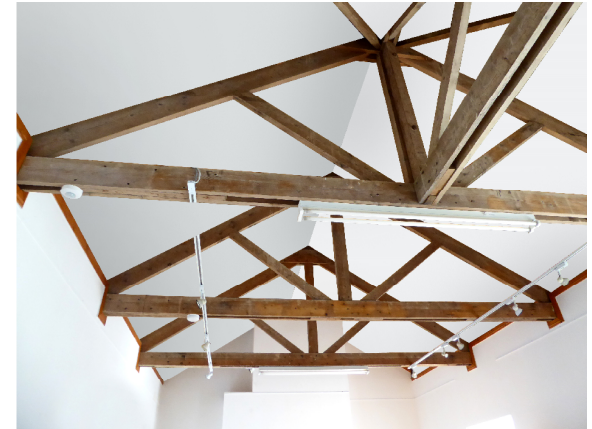
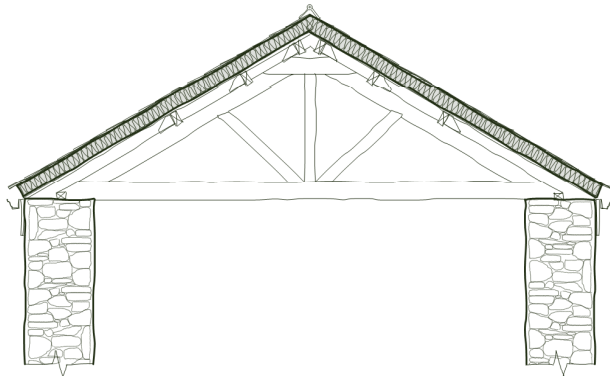
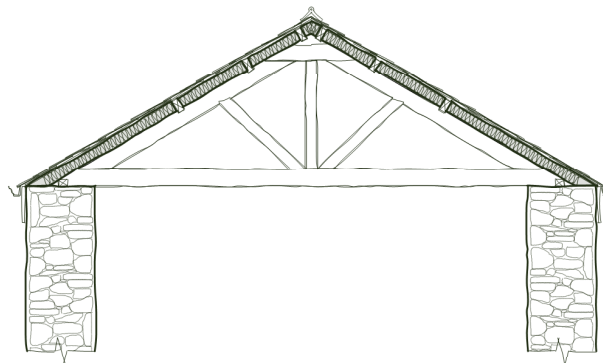
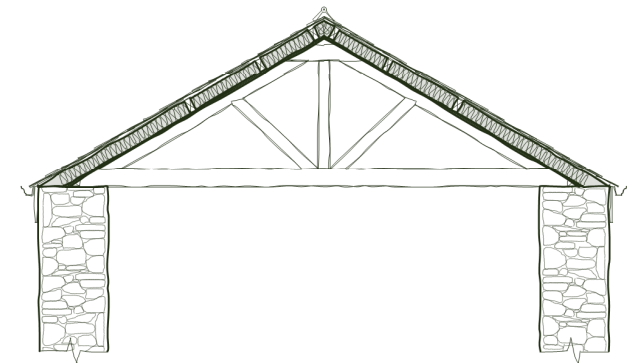
Indicative Roof Insulation Options

Option 01 Insulation over sarking

- Raises roofline
- Creates issues at eaves and verges, additional works required to adjust gutter level
- + Internal roof structure unaffected
